Spatial Disorientation in U.S. Army Helicopter Accidents: An Update of the 1987-92 Survey to Include 1993-95

Aircrew Health and Performance Division

March 1997

U.S. Army Aeromedical Research Laboratory Fort Rucker, Alabama 36362-0577

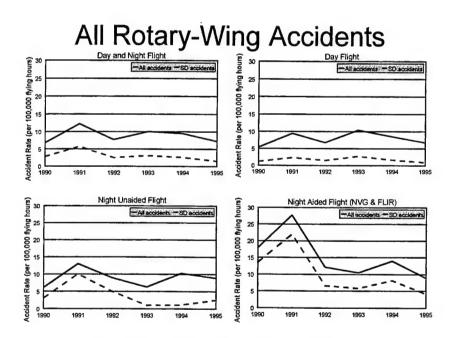
Figure 10. All rotary-wing accident rates.

Flight hours data for all flying were available for the whole period studied, and since 1990, specific daytime flying and the various forms of night flying data for each type of aircraft was obtainable. Where there were enough accidents to analyze, rates were calculated. In figure 9, it can be seen that SD accidents (broken line) represent an almost constant proportion of the overall (solid line) Class A through C accident rate. Although there is a downward trend after the peak during Operation Desert Storm, matters are not getting better. Figure 10 shows the overall rate and the rate broken down into the various types of flight for all helicopters. The night aided SD rate closely follows the overall accident rate for this category.

The solid line in figures 9 through 11 represent the overall accident rate, and the broken line, the SD accident rate.

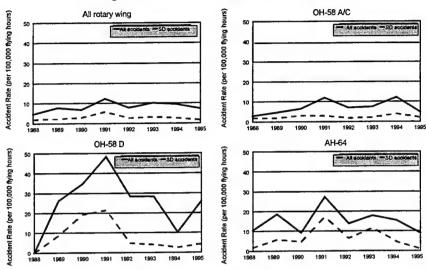
Figure 11. Day and night flight accident rates.

If the rates are broken down by individual types of aircraft, some differences become very striking (figure 11). As a comparator, the overall rate is in the top left. The other graphs show total day and night rates for the OH-58A/C models, the OH-58D, and the AH-64. It is evident that the OH-58D and the AH-64 have both a higher overall accident rate and an equally high SD rate.
